NRL Report 6005

Thermal Shock Evaluation of Refractory Materials as Rocket Nozzle Inserts

E. W. KAMMER AND H. SMITH

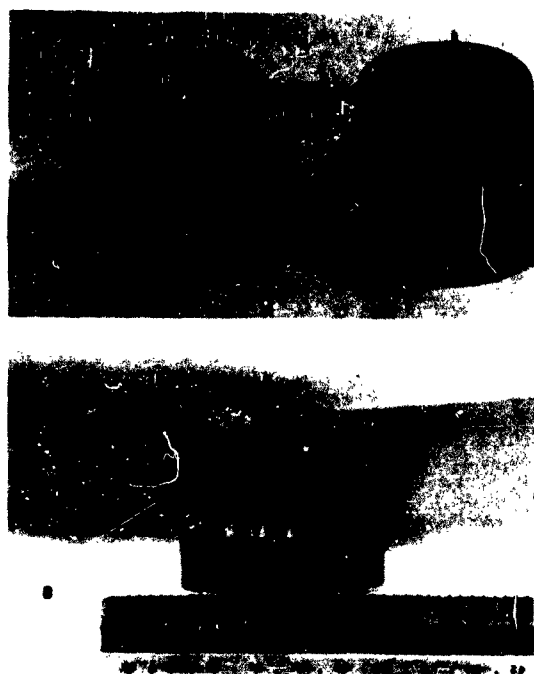
Fig. 6 — Welded strain gages (A) attached to a nozzle insert ready for connection to external circuitry and mounting into adaptor coupling on fuel case. Strippable foil transfer strain gages (B) cemented to a nozzle insert ready for connection into external circuitry.

A second strain gage type (Fig. 6B), a weldable fixture, has a foil resistance element cemented to a flexible metal base which is about 0.005 inches thick. The exposed edges of this base permit the gage to be spot-welded or seam-welded into the desired position on a structure; the strain being transmitted through the welds to the base and thence through the cement to the foil. The great advantage of this type gage is simplicity of installation. In exchange for this convenience some sacrifice is made in the fidelity of the strain reading through the devious linkage path between foil and structure. Vibrations of the flexible base similar to an edge-clamped diaphragm can complicate the output signal by being superimposed upon the structure distortion as seen by the resistance foil element. This type strain gage is also less intimately coupled thermally to the strained structure and some evidence of this lag in following the temperature of the insert surface will

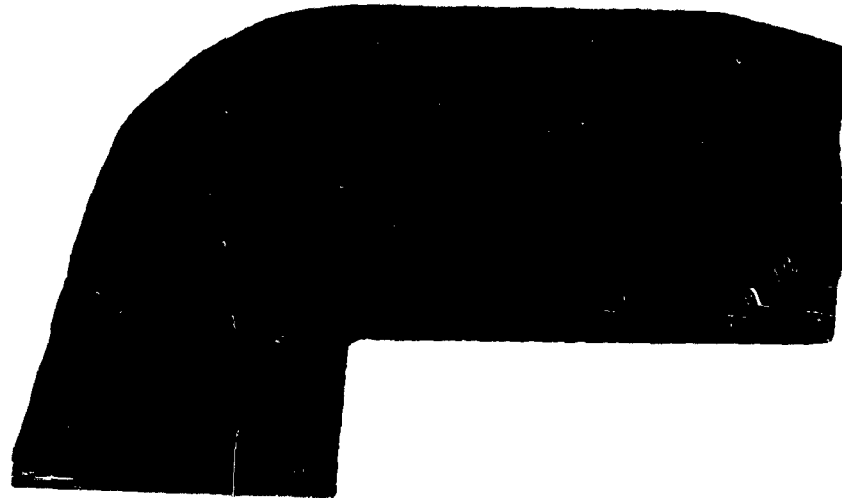
Fig. B4 - Longitudinal section of B-2 (NaOH etch) 4.7X

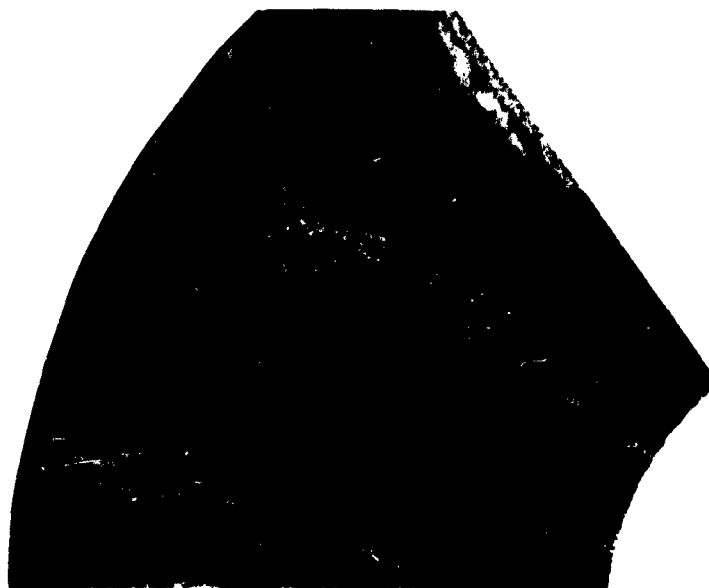
Fig. B10 - Transverse section of B-1 containing two longitudinal cracks along position E to F, below fillet (CP-4 etch) 8X
